CONCEPTUAL SITE MODEL AND DATA GAPS REPORT  
**Former Jensen Shipyard**  
FRIDAY HARBOR, WASHINGTON

Subject: DRAFT CONCEPTUAL SITE MODEL AND DATA GAPS REPORT  
TYPE, FORMER JENSEN SHIPYARD, FRIDAY HARBOR,  
WASHINGTON FRIDAY HARBOR, WA

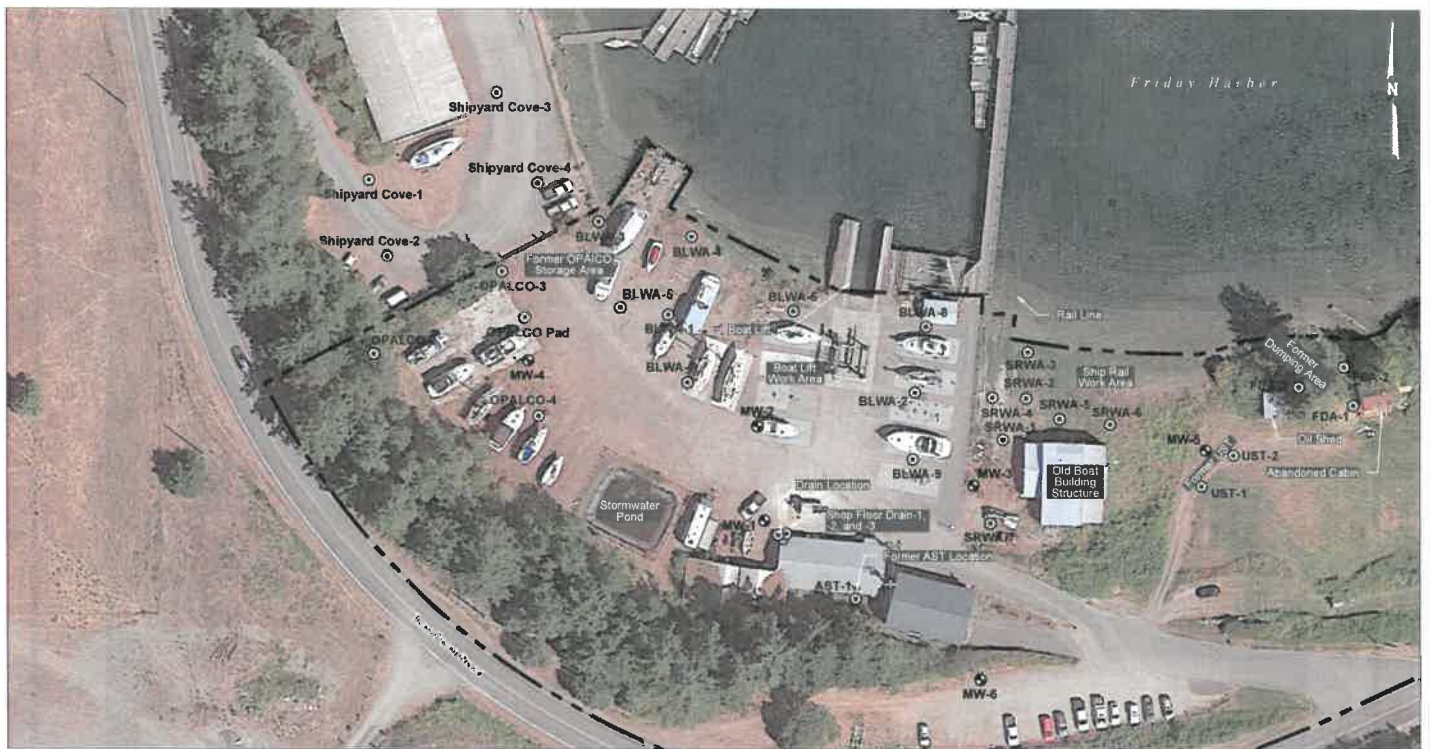
**FIG. 3**

The former OPALCO storage area is in the western portion of the site and extends north to the shoreline. Contamination in this area includes surface contamination of cPAHs, cadmium, copper, lead, and zinc. The contamination is likely due to shipyard operations in the area, including stripping paint. Additionally, OPALCO may have stored creosote-treated wood. The OPALCO building burned down and only the building foundation remains, contributing to the cPAH contamination in the area.

The BLWA is near the shoreline. cPAHs and zinc contamination exists in the surface soil. Copper, lead, and TPH-D are present a few feet deep, and are not vertically limited. Metals contamination is likely from stripping and applying paint in the work area. cPAH contamination is likely from the presence of treated wood in the area or draining bilges, which frequently contain engine oil or lubricants. TPH-D contamination may be from dumping of fuel, draining of bilges, or leaks while working on boats in the work area. Fill was likely brought in at some point to elevate this area, which may have been contaminated from its former area of use. The limits of contamination in the BLWA are not defined to the south.

The SRWA is to the west of the boat building, a structure where boats were historically built and repaired. A rail line exists to the east of the pier. Surface contamination includes copper and zinc, likely from the paint stripping operations, or loose paint flaking off boats during their transport. Deeper contamination includes cPAHs, arsenic, lead, mercury, and

The former AST area has TPH-D and oil-range petroleum hydrocarbons (TPH-O) contamination in soil and groundwater. This is likely due to leaks and/or spills from the AST, or during filling operations due to poor maintenance. The leaks and/or spills likely contacted soil and continued deeper, migrating to groundwater. Petroleum is present in groundwater at MW-1. Surface soil contamination of cadmium, copper, and lead is also present at MW-1. The shop building has a drain with an unknown outfall, which may be contributing to the local contamination.

1. General boat maintenance is site wide primary source.

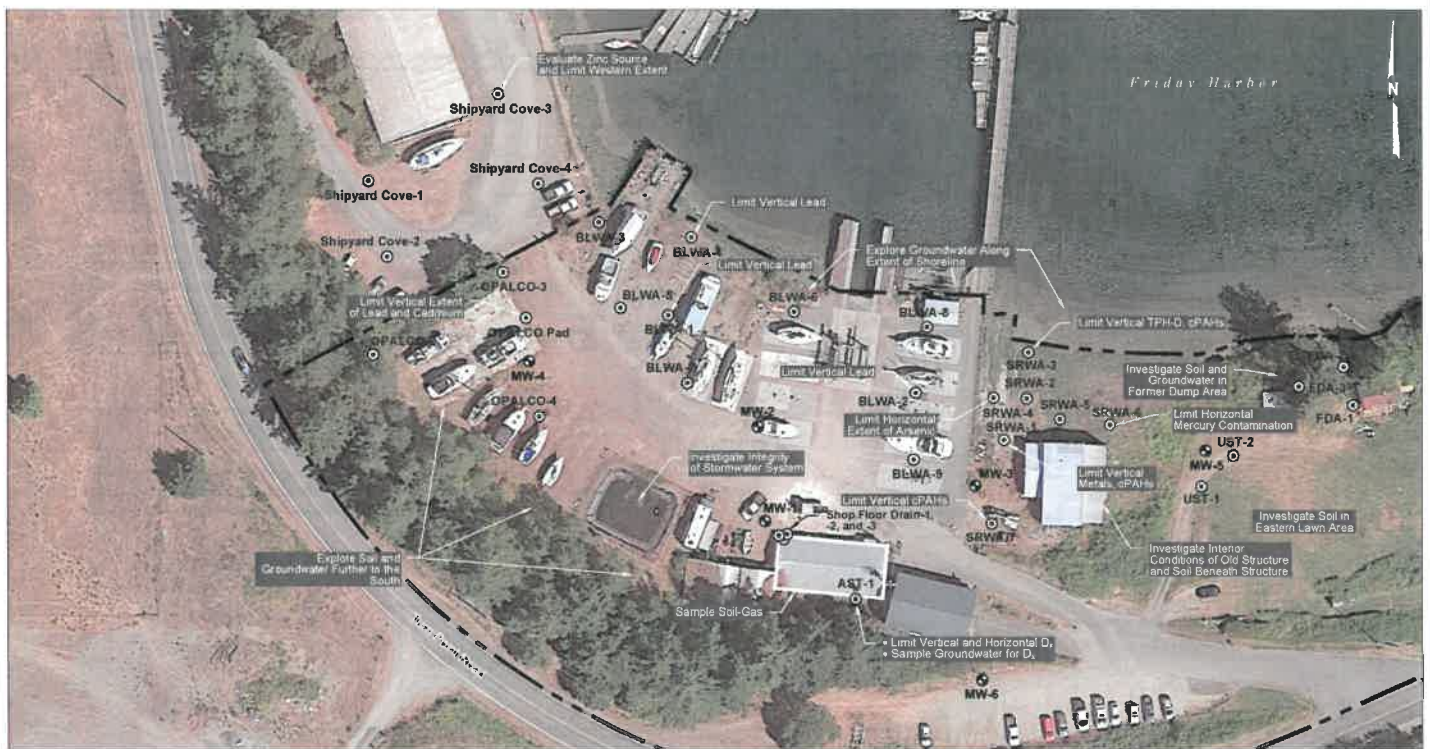
- Shoreline: Monitoring wells were not installed in areas downgradient of known contamination in the BLWA, the SRWA, or the OPALCO area. The groundwater conditions closer to the shoreline where there is risk for groundwater to infiltrate into the surface water is a data gap.

- Former AST: One groundwater sample was collected from MW-1, which is approximately 60 feet downgradient of the former AST and contained detectable concentrations of TPH-D and dissolved arsenic above MTCA Method A. Groundwater was not sampled in the direct vicinity of the former AST, where there is known elevated petroleum concentrations in soil. Groundwater conditions near the former AST is a data gap.

To fill in the data gaps, additional exploration and delineation is recommended. Additional recommended explorations are shown in Figure 5.
