Intertidal and Subtidal Conceptual Site Model and Data Gaps Report Jensen and Sons Boatyard and Marina

Port of Friday Harbor

August 2019

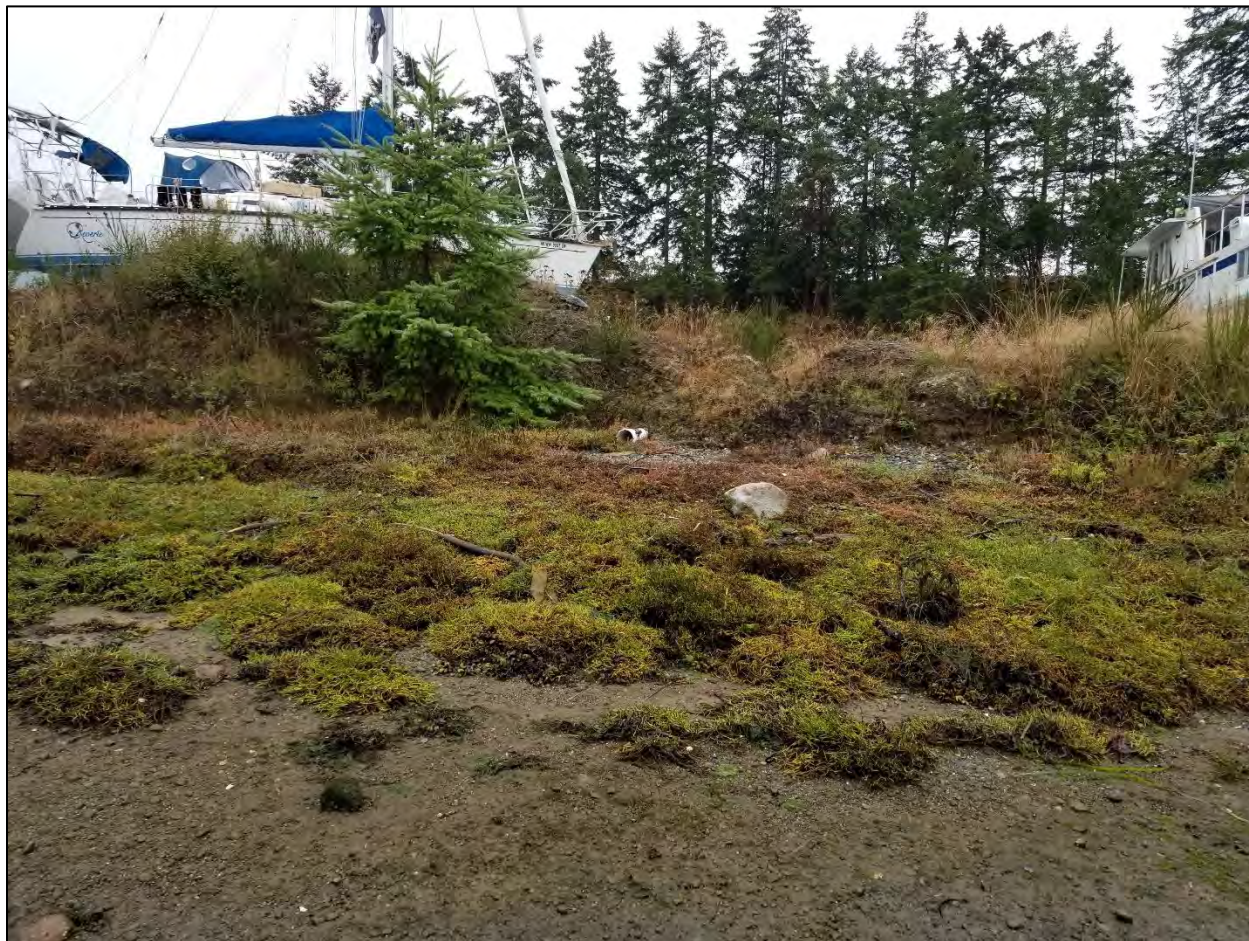
Figure 3. Outfall Photo

A single outfall pipe was observed on the Project site, but there is no evidence of discharge or seepage. No other point source outfalls have been identified as discharging to the embayment where Jensen's Shipyard is located. Marine water quality throughout the San Juan archipelago is generally considered to be good, although no water quality studies have been conducted for this embayment associated with the marina operation of other shoreline activities outside of the project site property. Anticipated maintenance improvements to the marina and potential moorage space reconfigurations are expected to require establishment of baseline water quality parameters as part of the regulatory process, so although this is technically a data gap, it is a minor one. The need for collection of surface water quality data will be discussed with Ecology as part of the identification of required studies for remedial investigation or regulatory process.

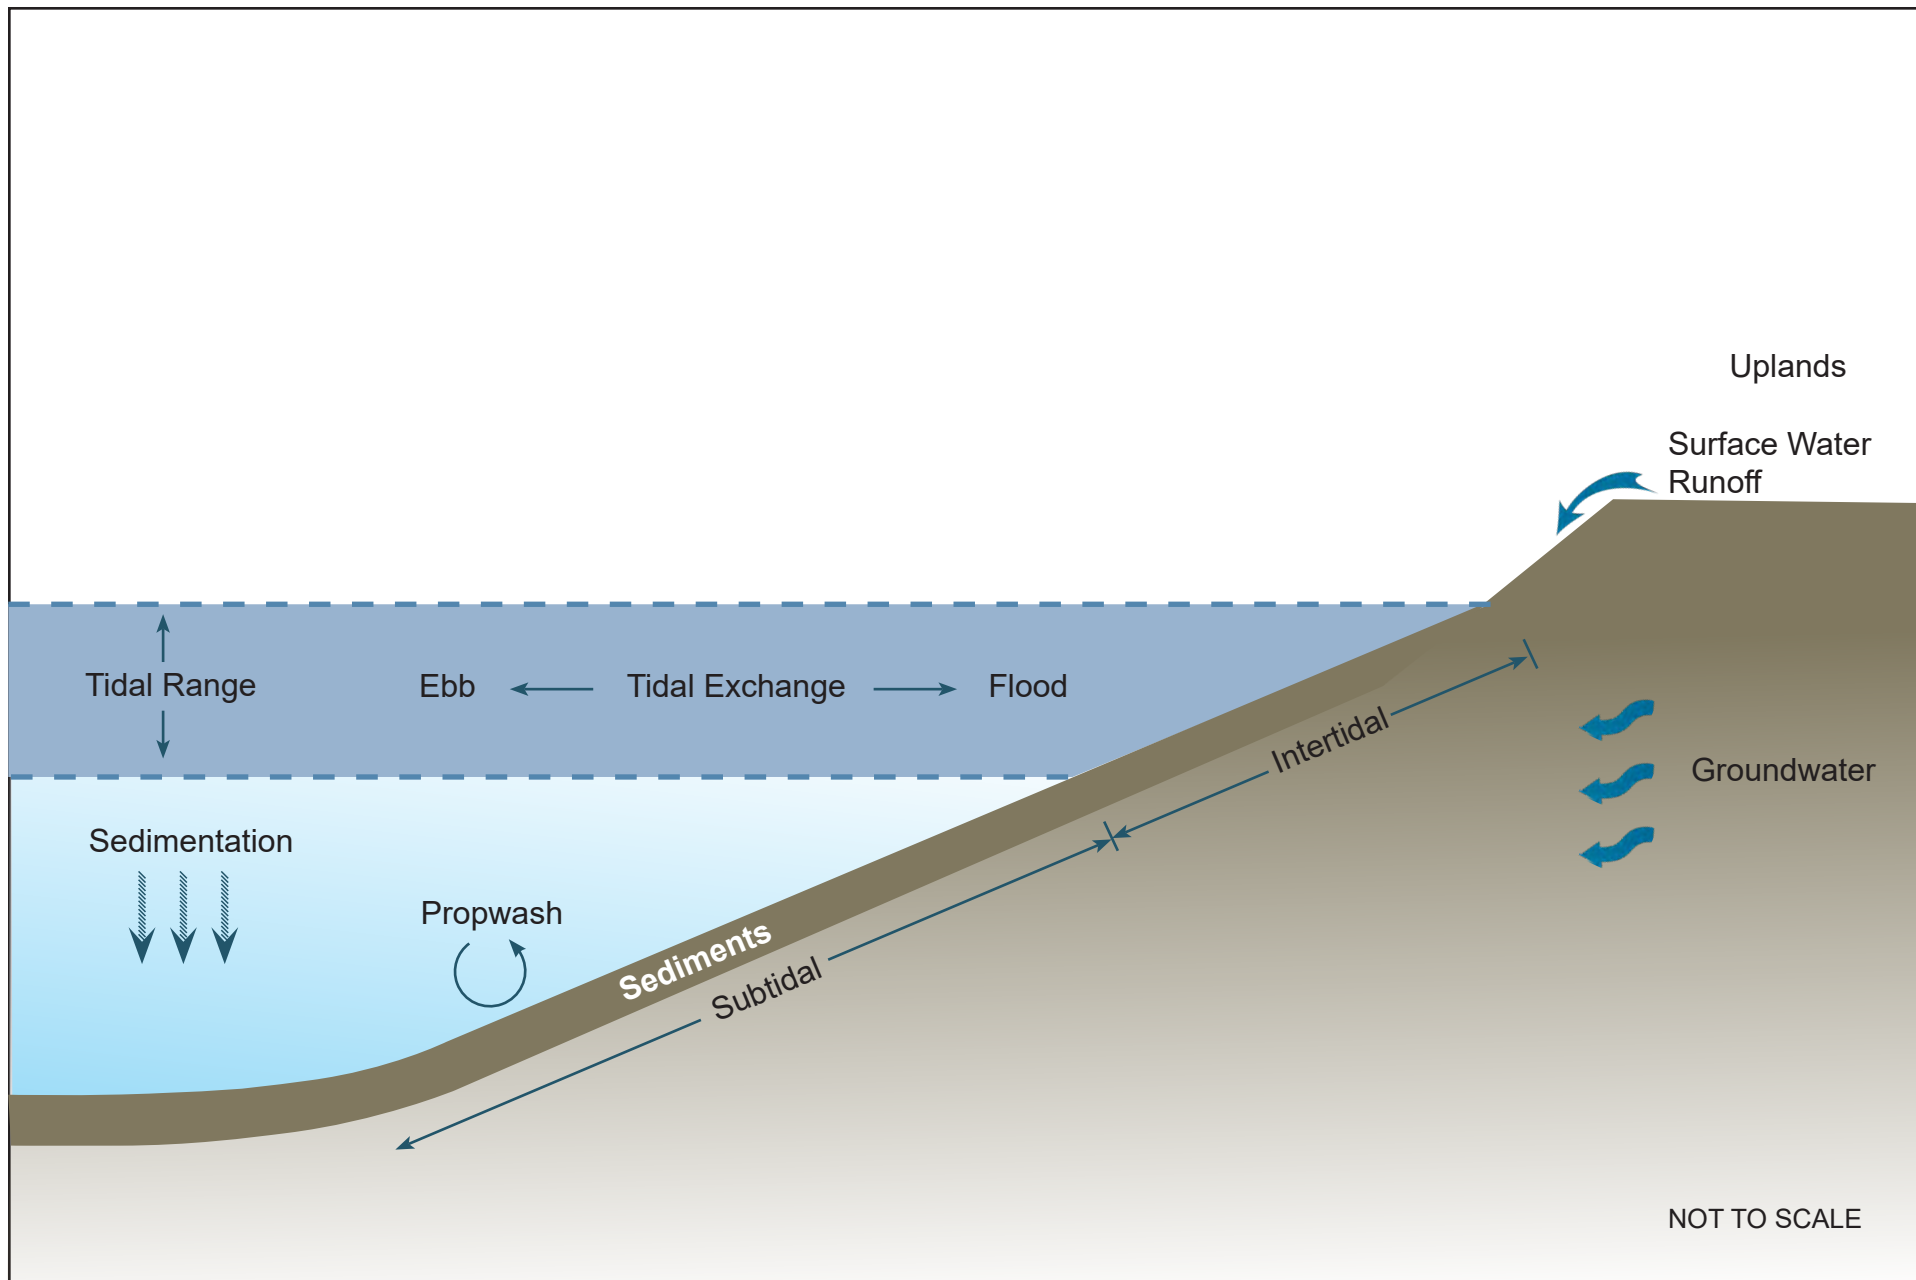
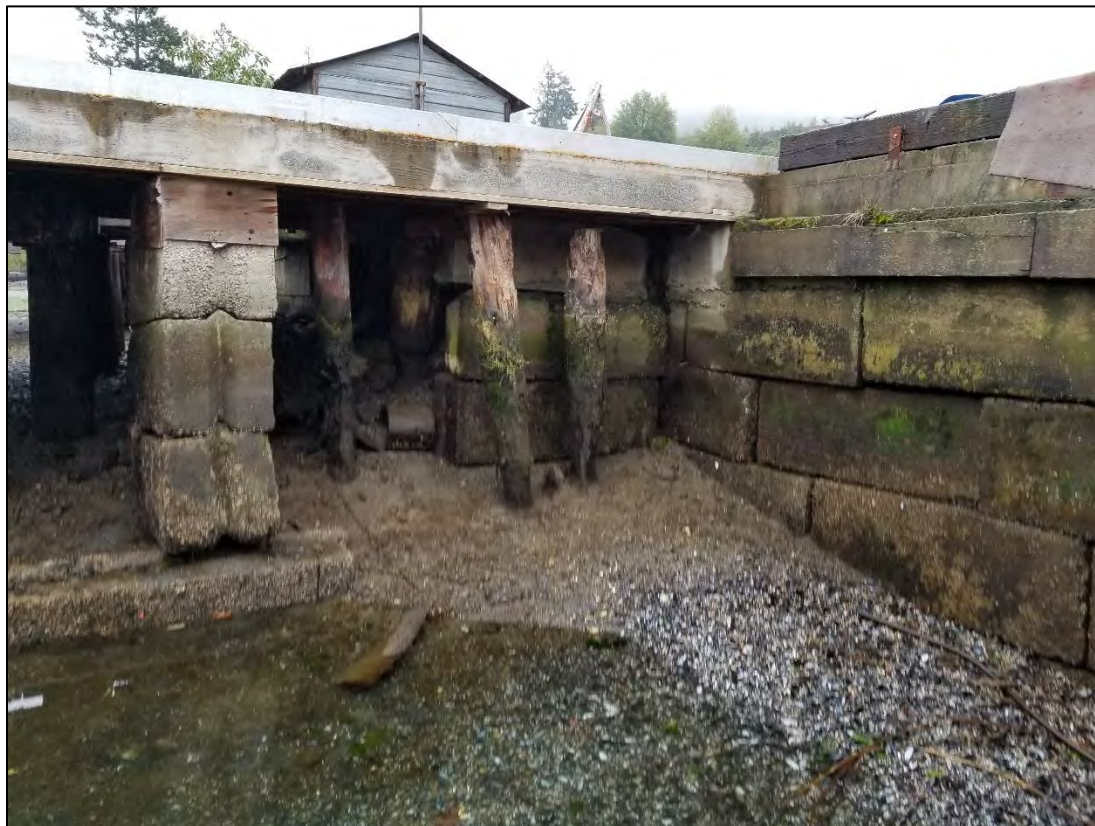
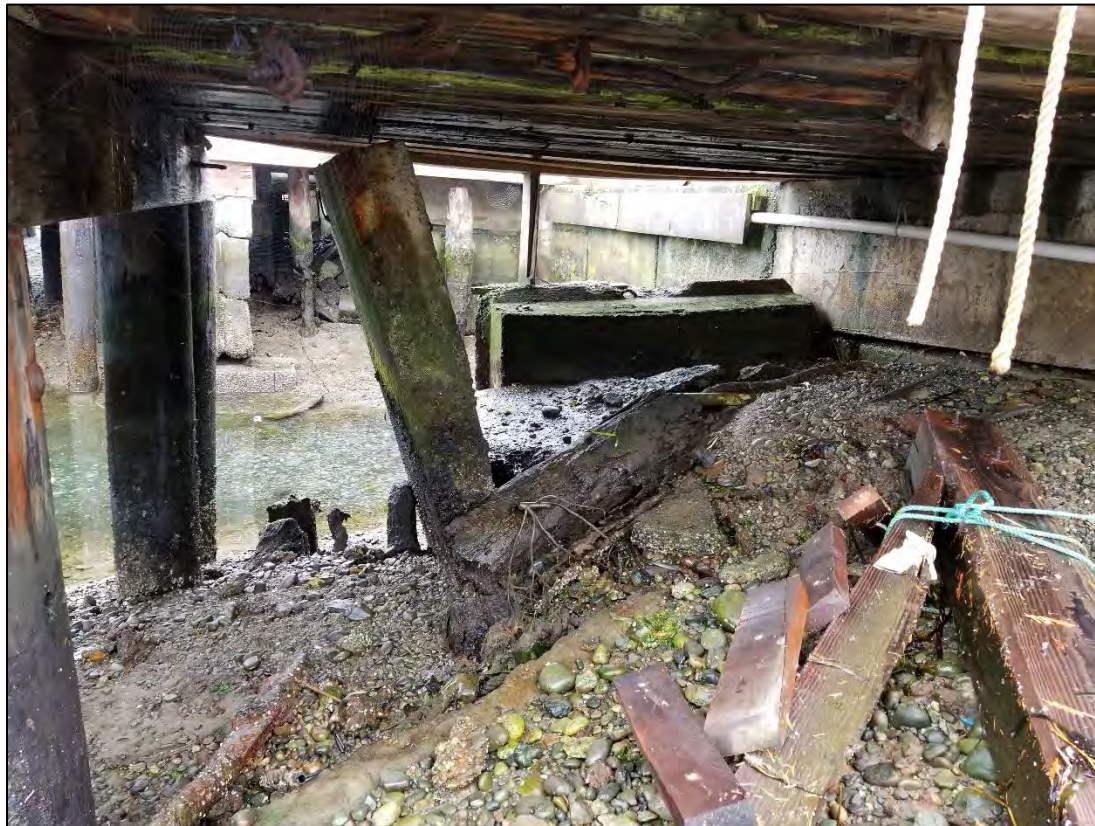
Figure 12. Travel Lift Pier

The existing travel lift pier required to haul vessels in and out of the water is at imminent risk of failure (Figure 12, Travel Lift Pier). Although an engineering condition assessment has not been performed on this structure, the creosote-treated piling that support the structure are in an advanced state of decay and the ecology-block shoreline revetment is failing. Several piles have already failed and substantial deterioration is visually evident in many others. The existing revetment is being undermined and upland soils are beginning to spill into the intertidal zone. The travel lift pier is located in an area where preliminary surface sediment sampling (WE, 2018c) detected several COPCs that exceed regulatory criteria (TBT, PCBs, metals, PAHs, dioxins/furans). The required infrastructure replacement provides a timely and cost-effective opportunity to reduce site risks by addressing known COPCs.

Additionally, a substantial amount of the existing subtidal marina infrastructure is in a similar state of disrepair as the travel lift pier. Creosote-treated piling are in an advanced state of decay, including several that have already failed. Many of the walkways are supported by degraded open-cell Styrofoam floats. The Port is currently developing plans to complete substantial maintenance and redevelopment of the existing marina infrastructure.

To inform an interim action associated with required maintenance of the travel lift pier, priority investigations include integration of the upland and aquatic data sets, additional sediment sampling to define the nature and extent of contamination, and completion of a cultural resources assessment. In order to meet anticipated timelines associated with federal permitting requirements, we recommend that these priority investigations be expedited by August 2019. In addition to the sediment sampling that would facilitate travel lift maintenance, completion of marina redevelopment plans also requires an expedited wind-wave analysis. We recommend initiating this priority analysis by June 2019.
