Waterfront Master Plan Addendum 2016

The purpose of this addendum to the Port of Friday Harbor Waterfront Master Plan is to incorporate the "over the water" portions of the Ports waterfront into the plan. This addendum will guide future development and improvements at this site.

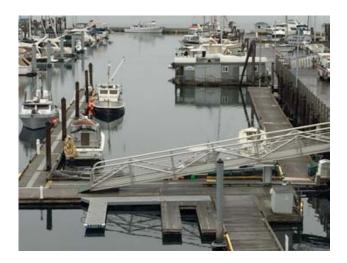
The life cycle analysis of these two floats was rated as fair with replacement recommended in 2014—2019. If structural walers and bull rails are replaced life span can be extended. There are some floatation issues on the bypass float that may require further maintenance to extend the life span. Challenge at this location is pump-out station and lift station shut-downs.

6. Rafting & By-pass Floats

The activity in commercial fishing has decreased over time. A reconfiguration of this area might offer larger moorage slips which is currently in short supply and which generate significant revenues.
